UNUSUAL OCCURRENCE REPORT

1. UOR Number EG&G-85-17
Facility Number ATR-85-3
2. Status & Date Initial
* Interim
X Final 11-13-85

Test Reactor Area (TRA)
Test Reactor Programs Division
Idaho National Engineering Laboratory (INEL)

Radioactive Soil Contamination - Hot Waste Line Leakage

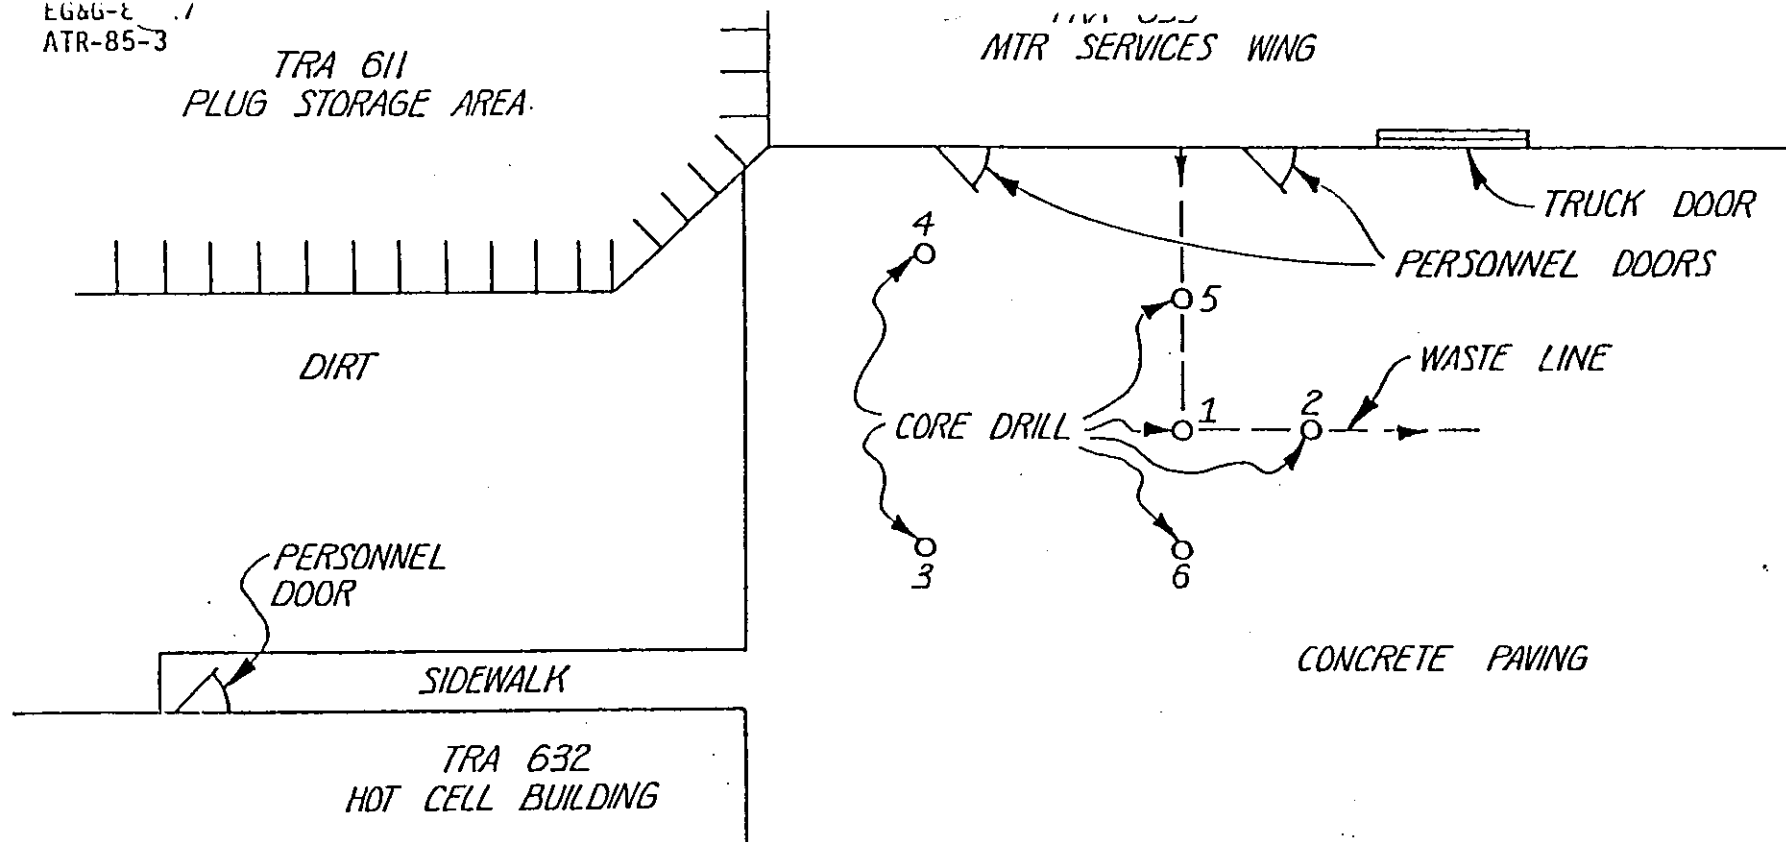
SKETCH 2 DES-6-85

RESULTS: Six 8-inch diameter concrete cores removed at locations shown in Sketch No. 2, show the highest surface radiation levels are present at a position estimated to be over an elbow in the waste line shown in Sketch 2.

HOLE #	BOTTOM	RADIATION LEVELS UNDER SURFACE					CONCRETE	RADIATION CONCENTRATION AT SURFACE ($\mu\text{Ci/gm}$)
		UP1'	UP2'	UP3'	UP4'	UP5'		
1	75 MR	550 MR	15 R	16 R	12 P	10 MR	300 MR	$1.3 \text{ E-}0$
2	0	0	0	0	0	0	0	$5.4 \text{ E-}5$
3	0	.1 MR	.2 MR	1 MR	10 MR	.4 MR	10 MR	$2.6 \text{ E-}2$
4	NR	NR	0	0	0	0	0	$1.9 \text{ E-}5$
5	0	0	0	0	0	0	0	$3.3 \text{ E-}6$
6	0	.6 MR	.6 MR	1 MR	10 MR	1.5 MR	20 MR	$4.0 \text{ E-}3$

2. Core drill through the concrete paving directly over the probable source of the leak and at other locations to obtain radiation levels and soil samples for radioisotopic analysis to determine the extent of the radioactive soil contamination.

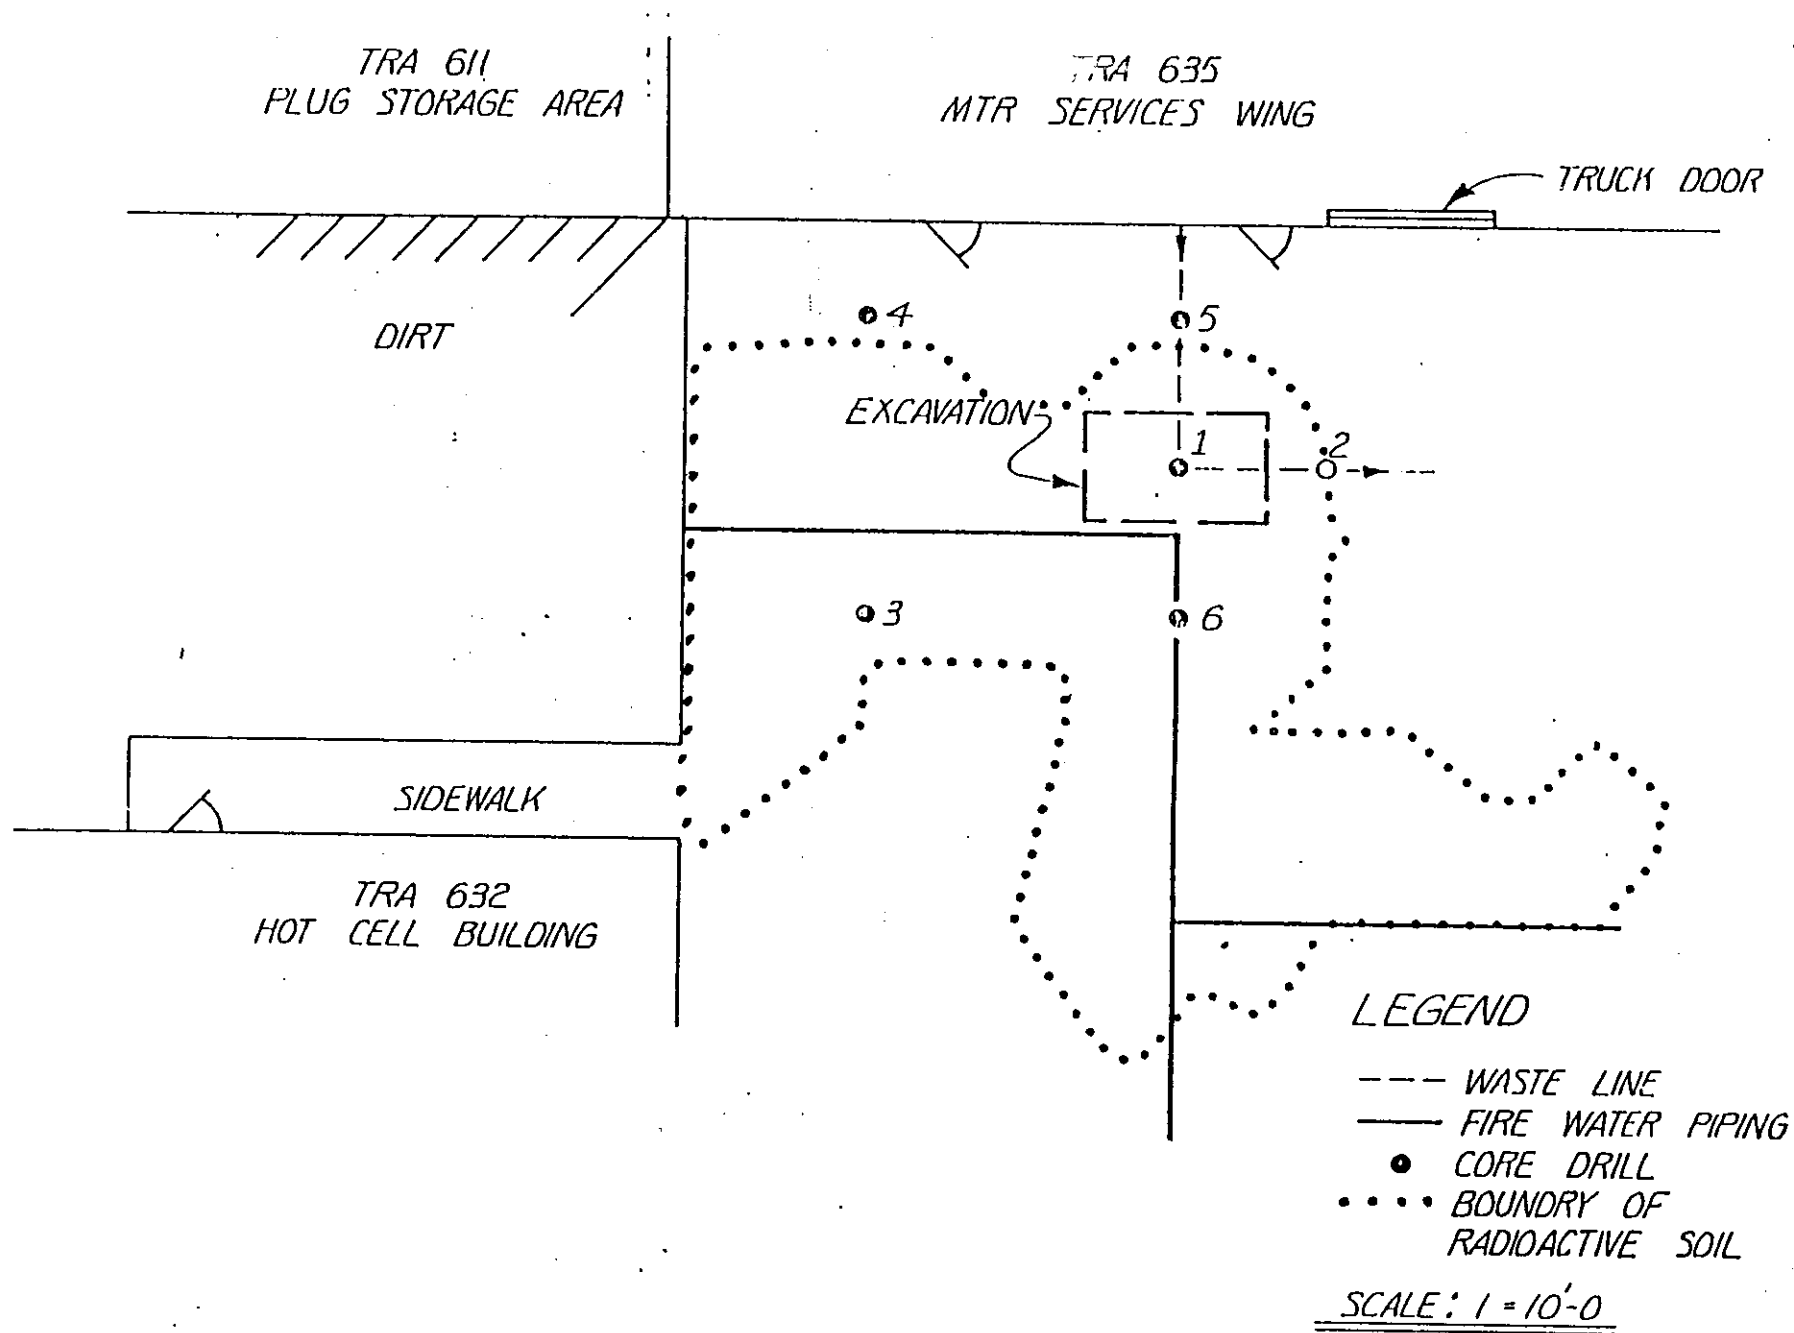
SKETCH 3 DES-6-85

The extent of migration of the radioactive contamination under the concrete pad was characterized. An intrinsic Germanium detector, a multichannel analyzer and a tungsten collimator were used to evaluate photopeaks emanating from the contaminated soil. The attached sketch Number 3 identifies the boundaries of the underground contamination. It is obvious that the leakage from the waste line followed the adjacent firewater line trenches. The firewater line was installed in 1978.
